# Durability Evaluation Inspection Checklist Photos

## Exterior Water / Moisture

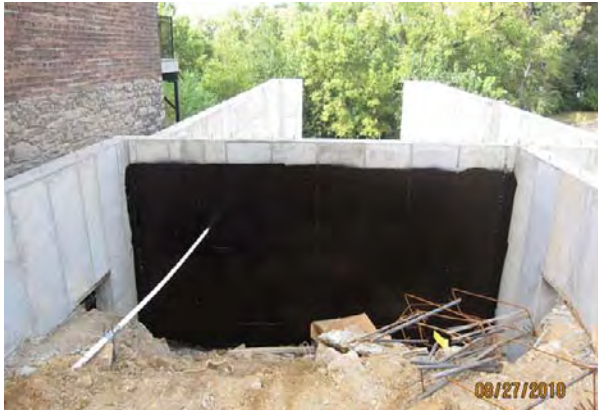
foundation damp proofing

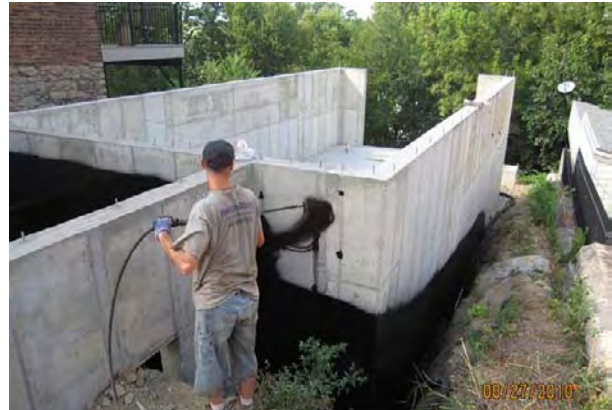
foundation damp proofing

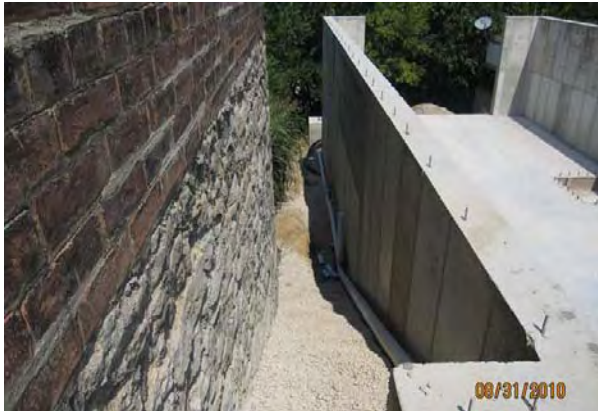
foundation damp proofing, underground downspout lines, gravel backfill

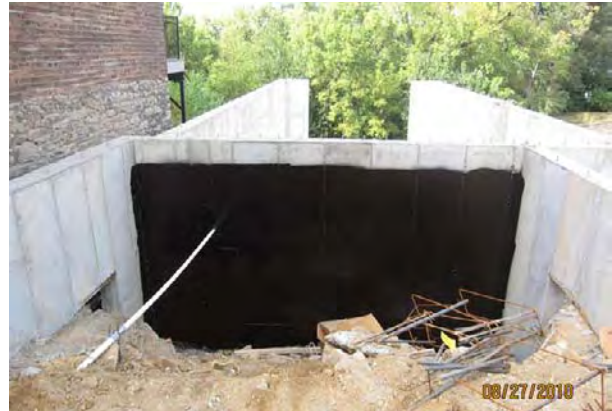
foundation damp proofing, underground downspout lines, gravel backfill

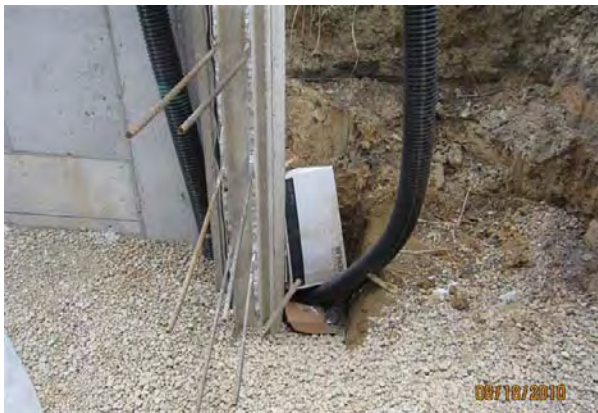
interior foundation drain thru rear exterior foundation wall, grade at North rear wall approx. 4' below lower level slab

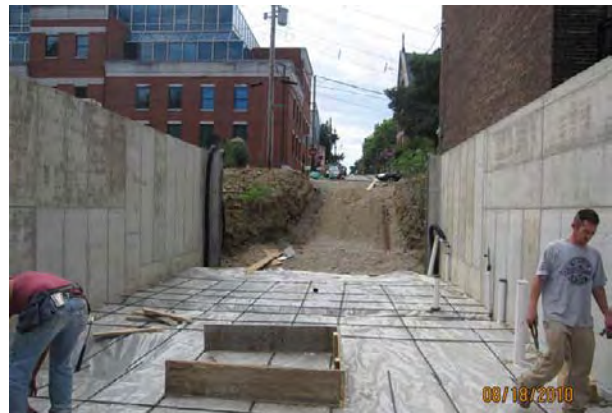
vapor retarder under slab, (2) interior foundation drains ready for pass thru @ South front wall @ garage

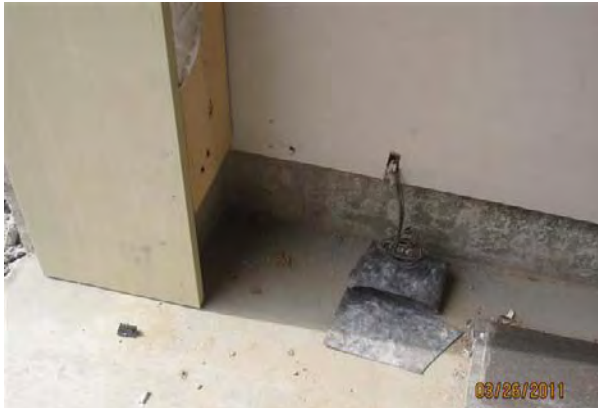
slope garage floor to main vehicle entry  
low

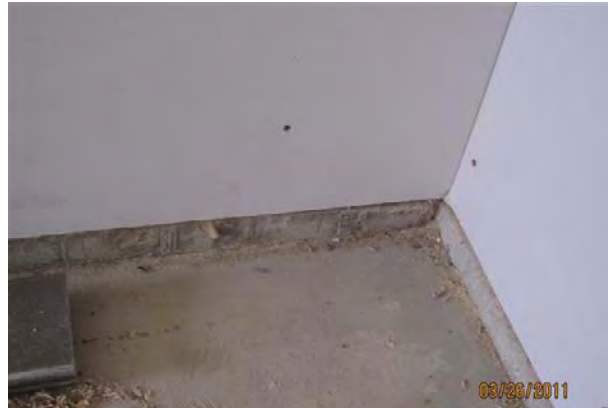
slope garage floor to main vehicle entry  
high

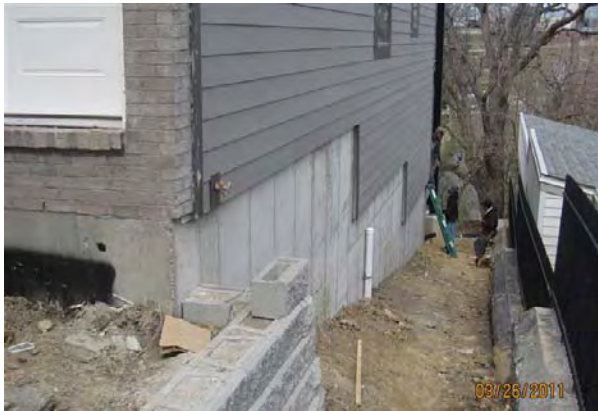
hold grade 8" below top of foundation

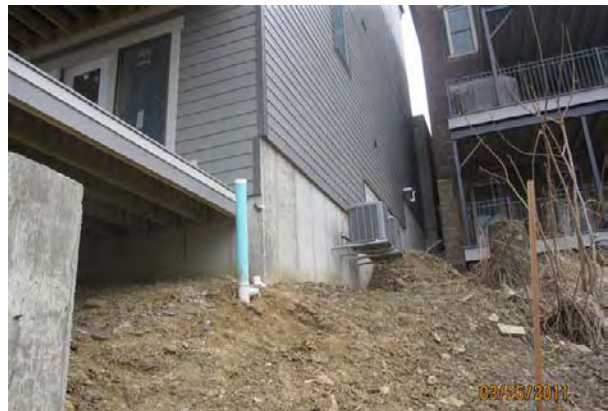
hold grade 8" below top of foundation

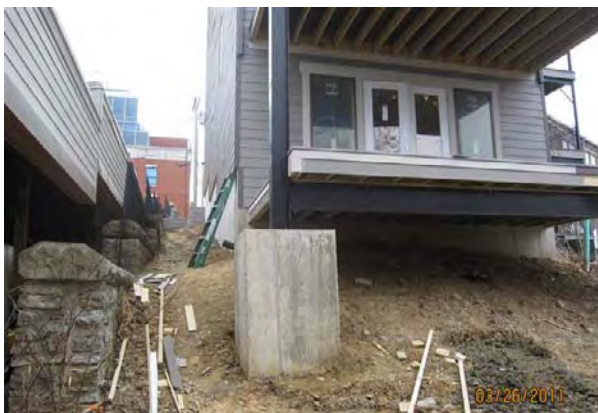
hold grade 8" below top of foundation

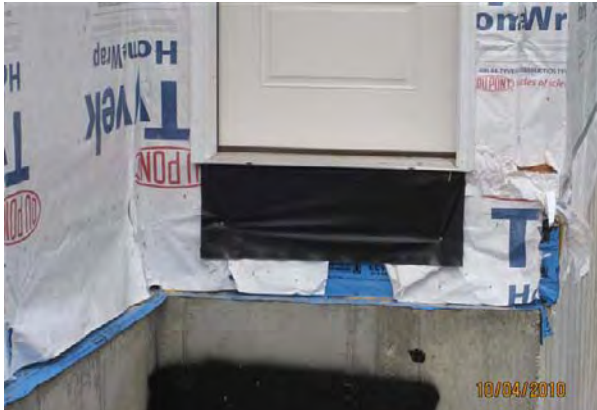
flashing @ masonry walls

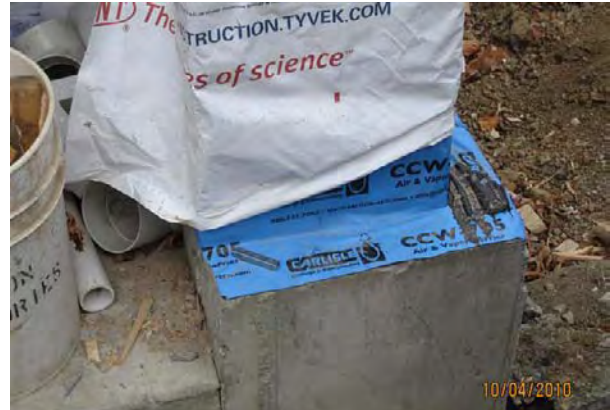
flashing @ masonry walls

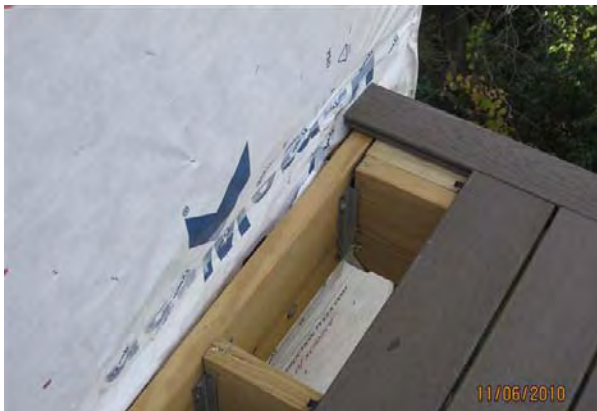
uninterrupted drainage plane @ ledger

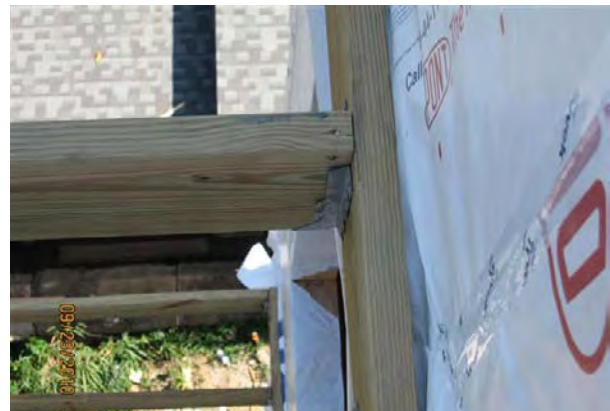
uninterrupted drainage plane @ ledger

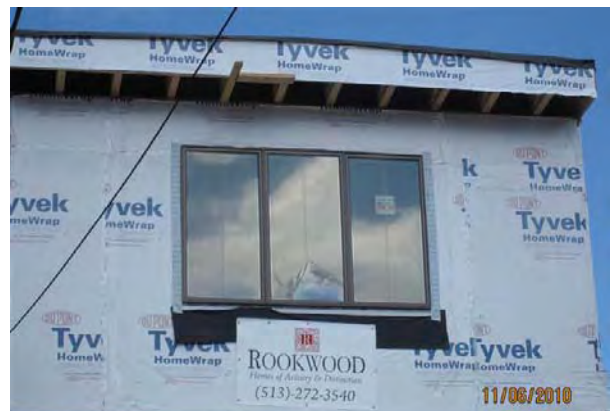
flashing membrane & tape @ openings

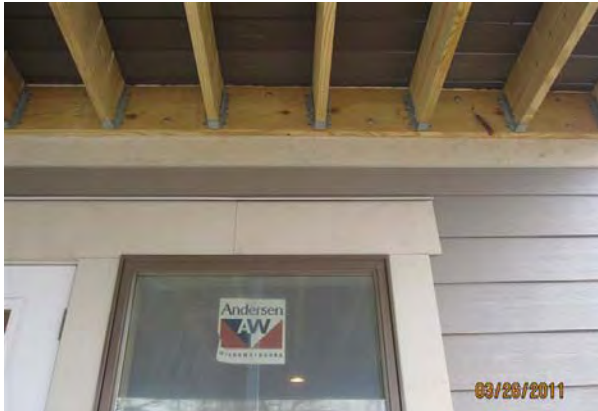
flash exterior door & windows

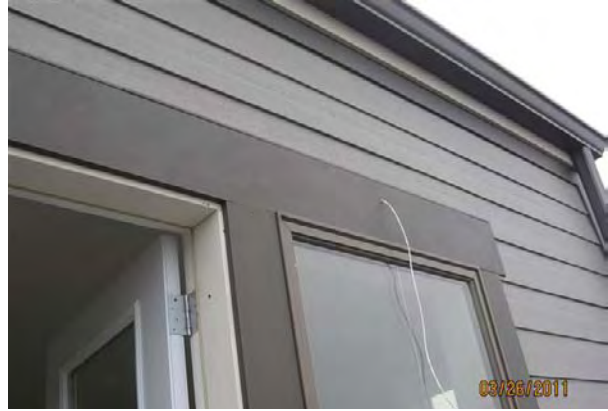
flash exterior door & windows

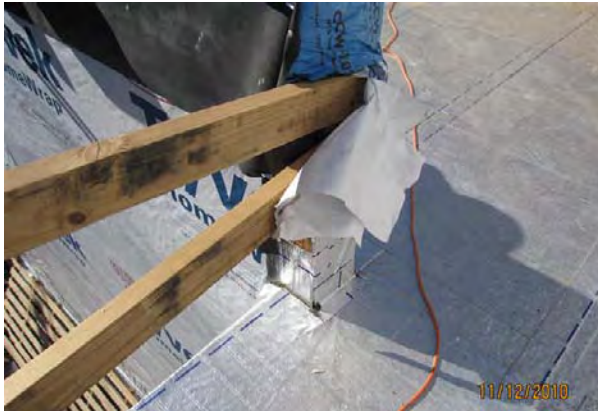
garage roof/deck flashing/counter flashing

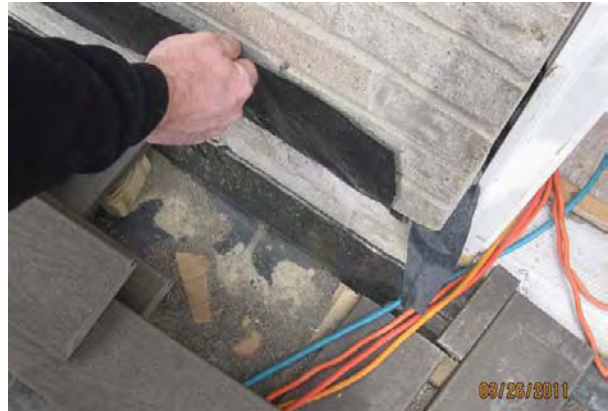
masonry flashing/counter flashing

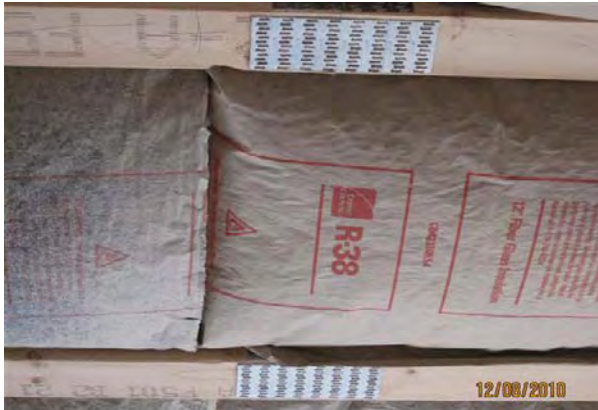
R-38 roof insulation

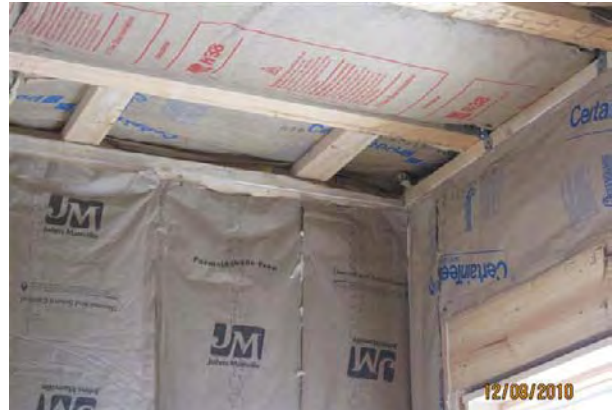
insulation over top plates

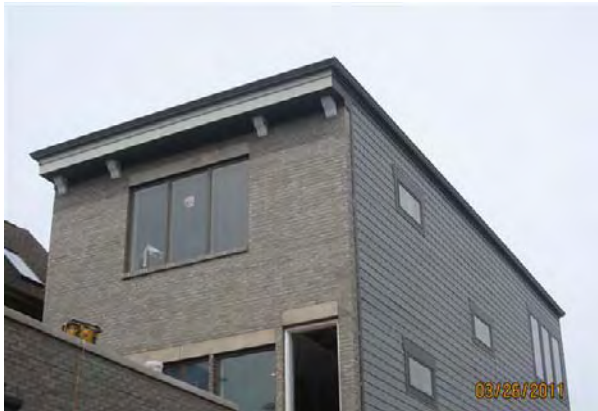
gutters

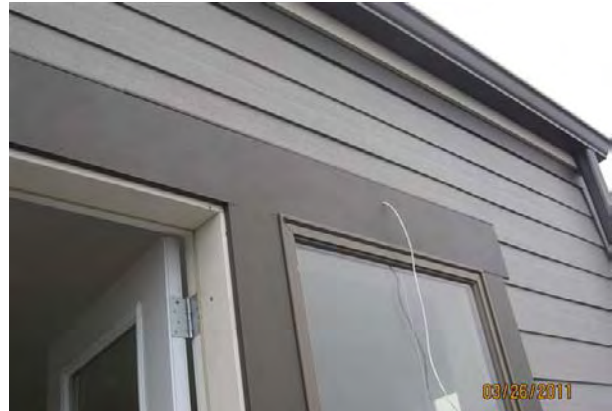
gutters & downspouts

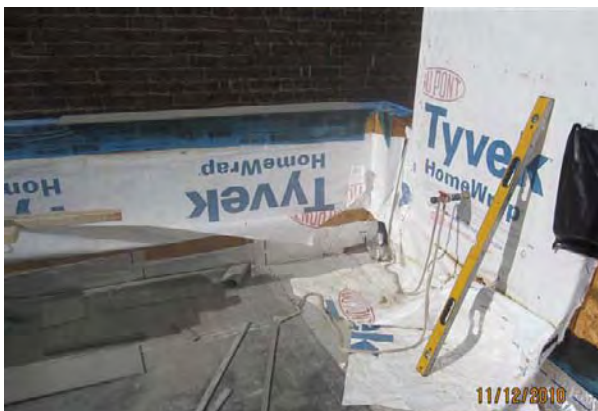
garage roof/deck flashing/counter flashing

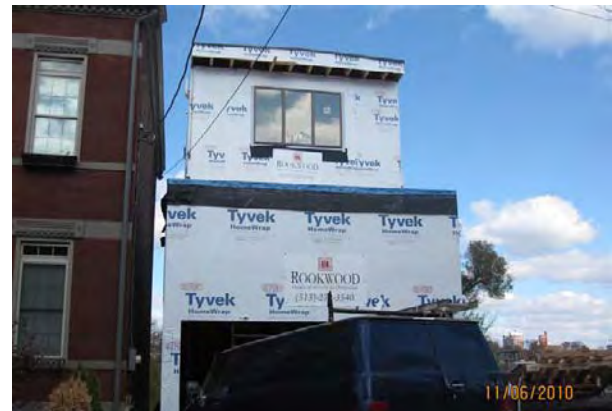
roof flashing wrap over vertical walls/roof

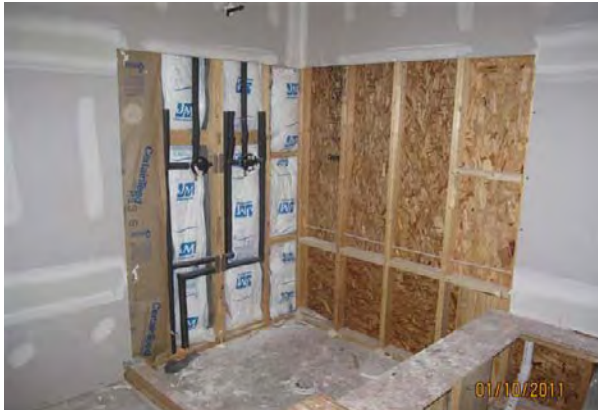
nonpaper faced backer board used in all tub and shower locations

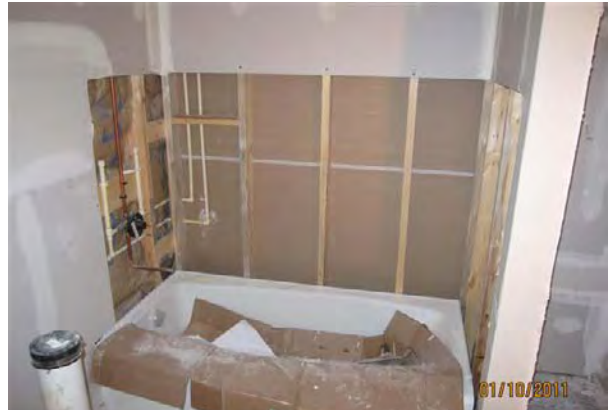
nonpaper faced backer board used in all tub and shower locations

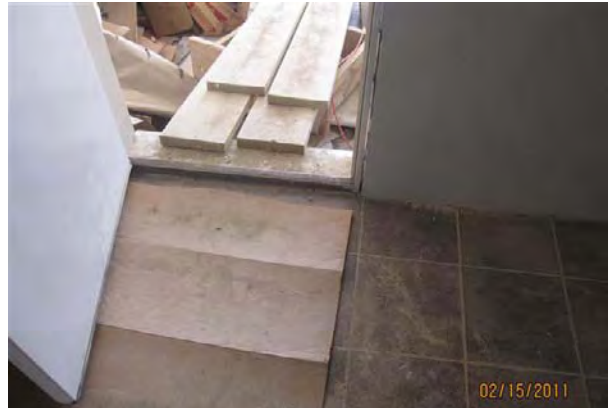
water-resistant flooring laundry room

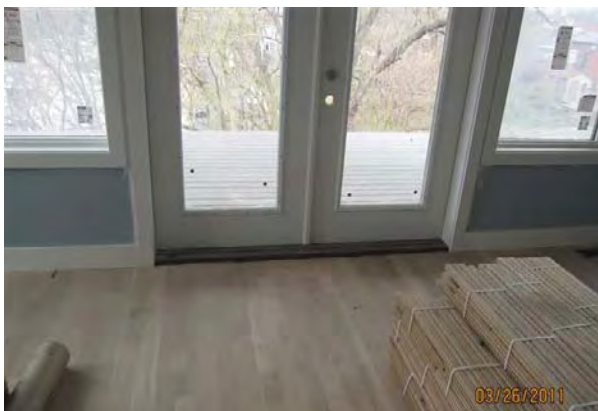
water-resistant flooring 3' of exterior doors

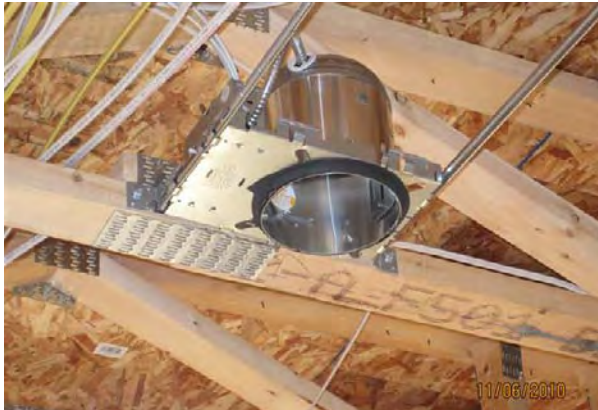
light fixture gaskets @ insulated roof

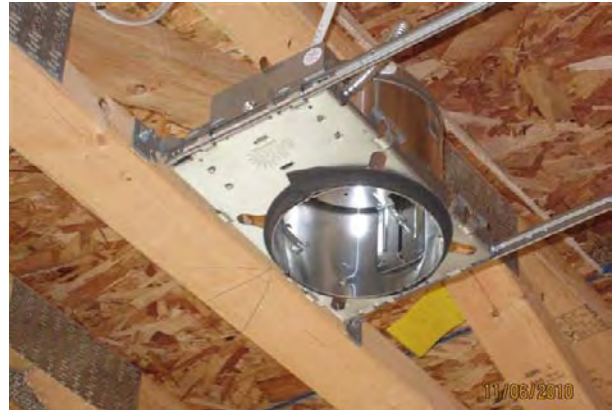
light fixture gaskets @ insulated roof

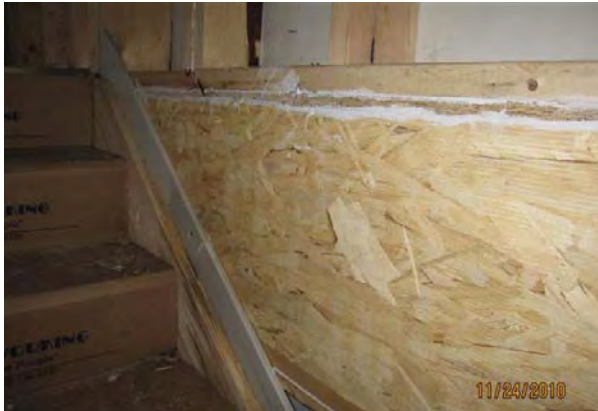
air infiltration caulking

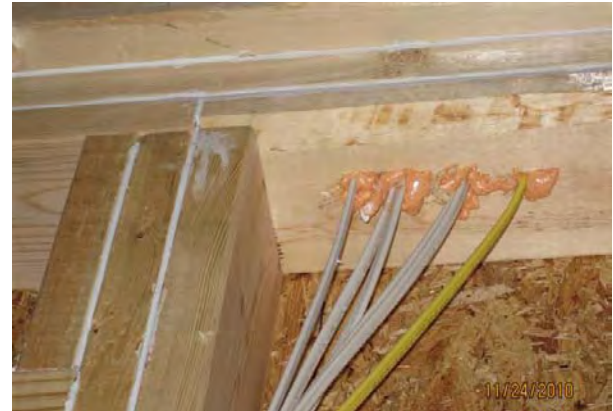
air infiltration caulking

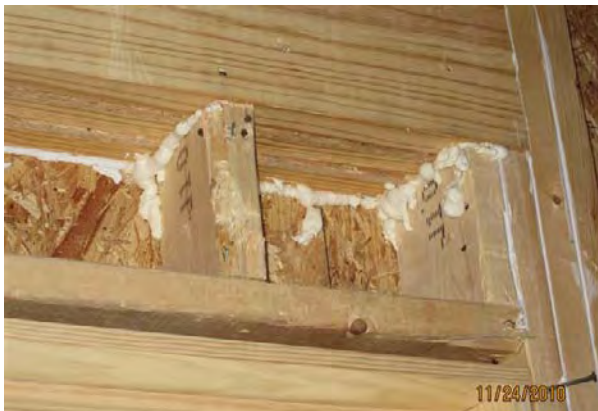
air infiltration caulking

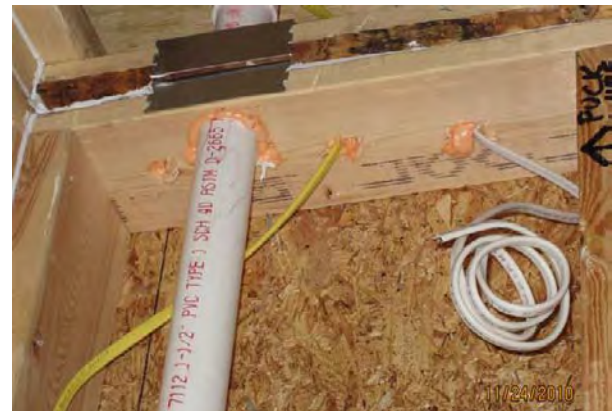
air infiltration caulking

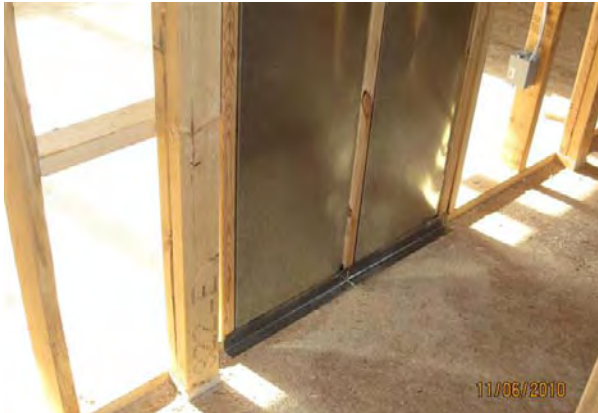
vertical HVAC ducting

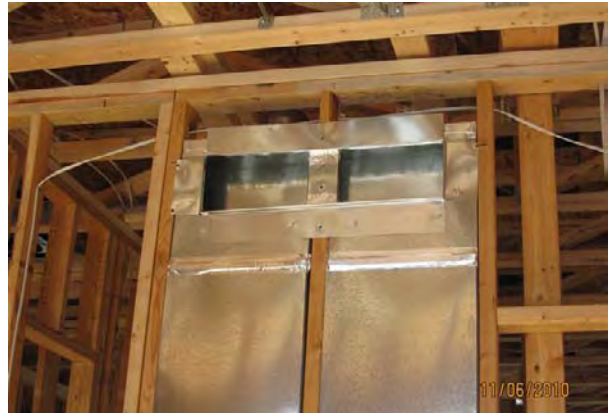
vertical HVAC ducting

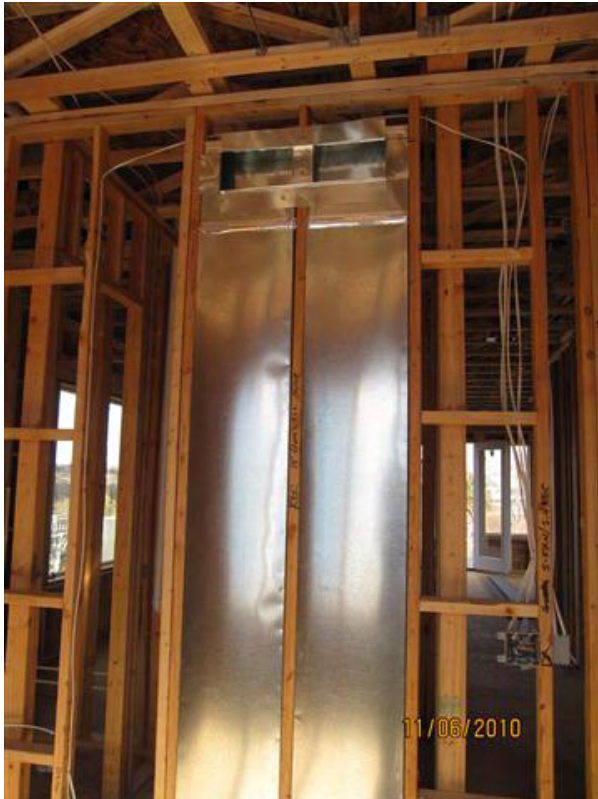
vertical HVAC ducting

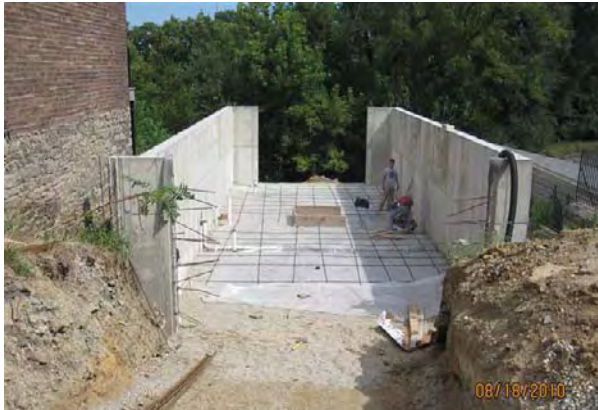
10" concrete foundation walls

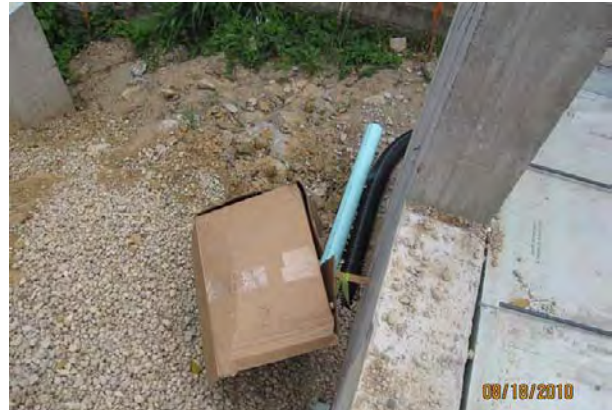
10" concrete foundation walls

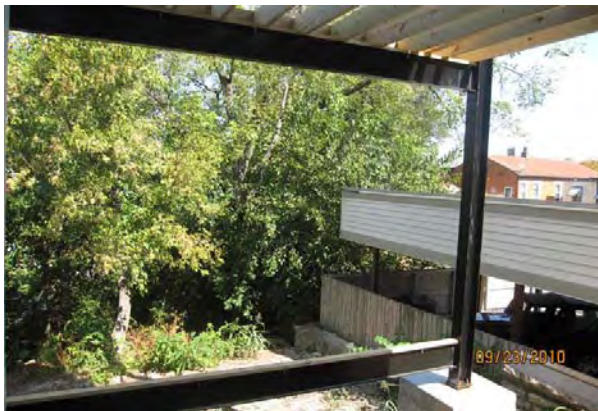
grade - no wood in contact

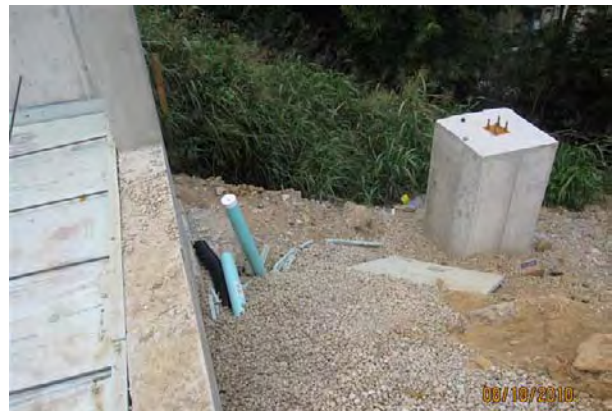
grade - no wood in contact

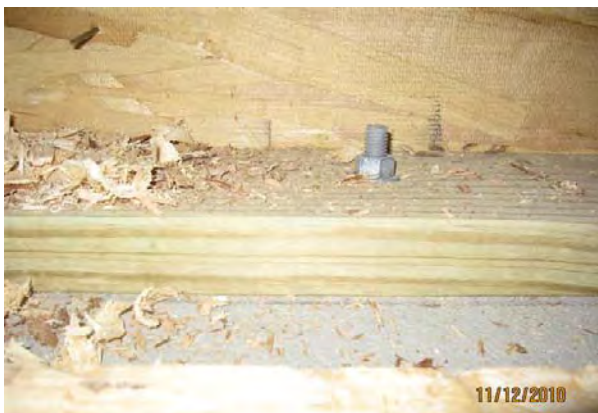
wood sill plate sealer separation

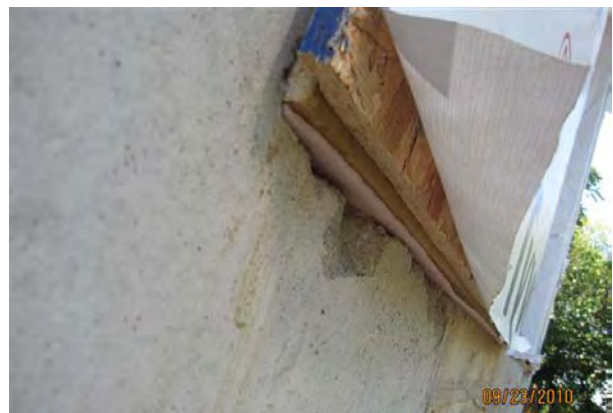
wood sill plate sealer separation

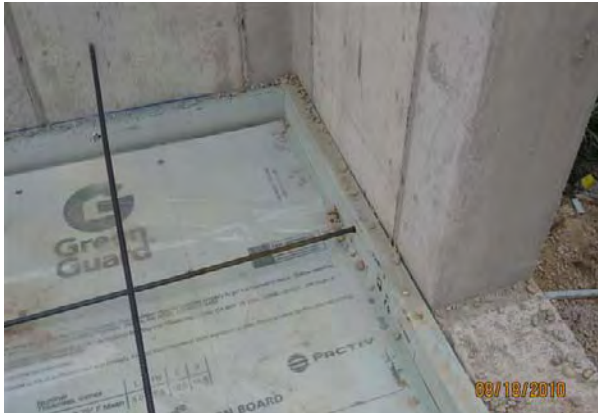
slab edge insulation @ walkout

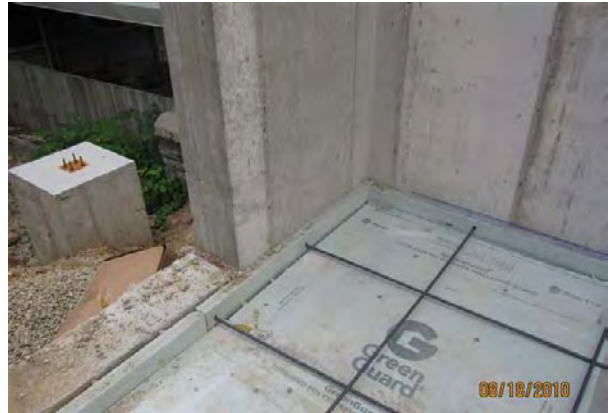
slab edge insulation @ walkout

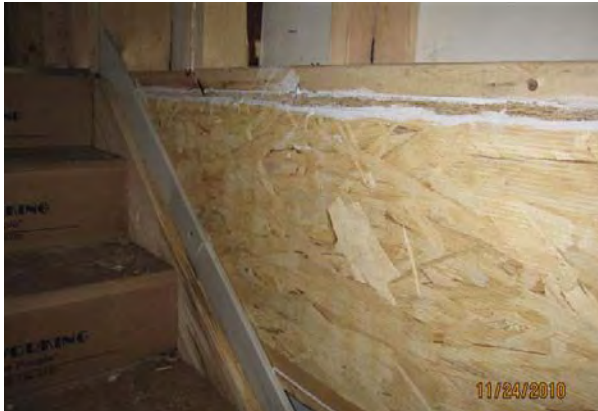
air infiltration caulking

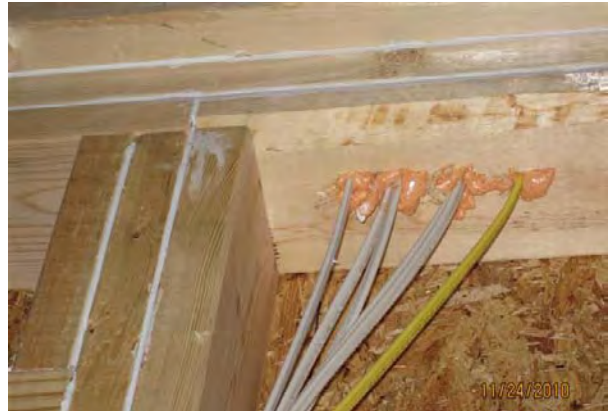
air infiltration caulking

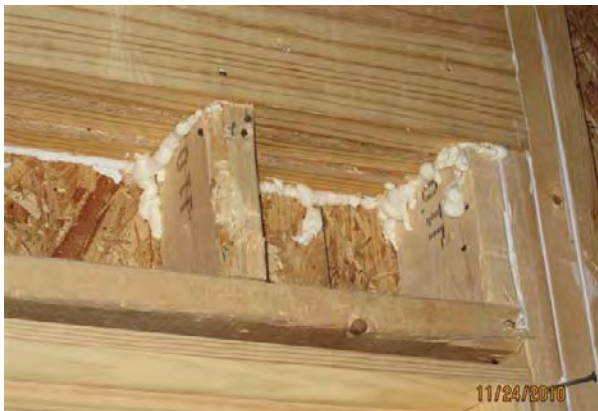
air infiltration caulking

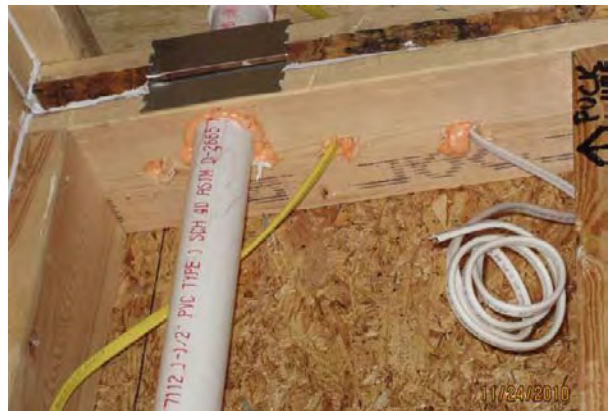
air infiltration caulking

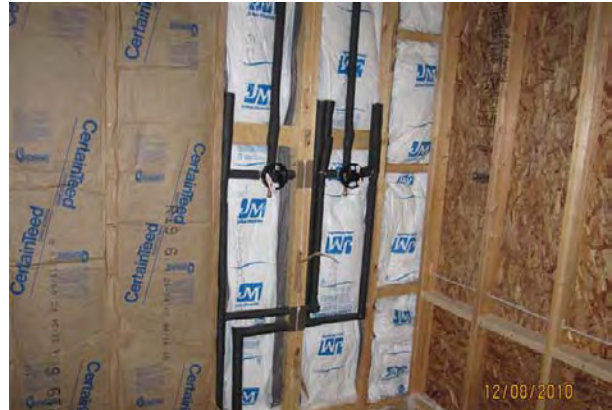
insulation system

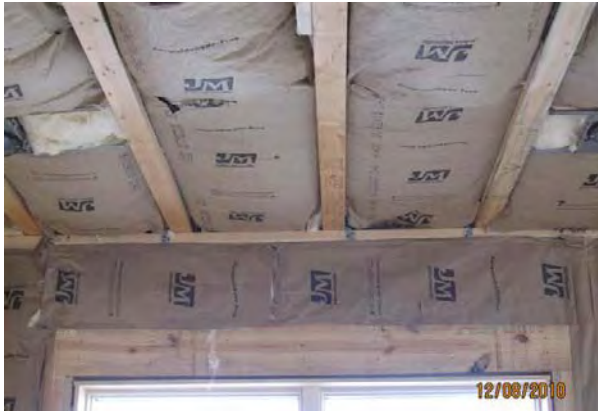
insulation system

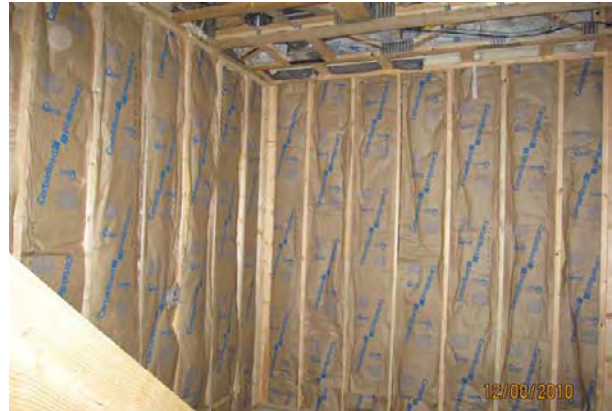
insulation system

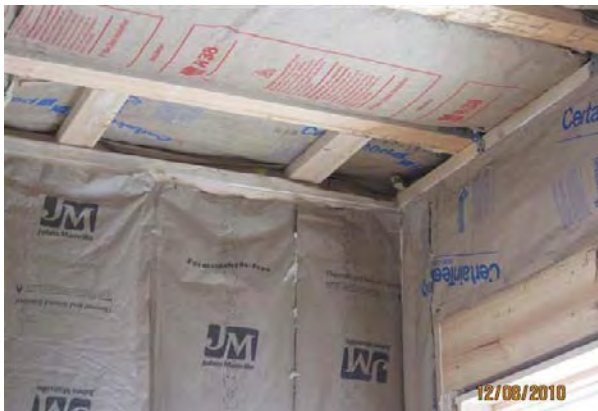
insulation system

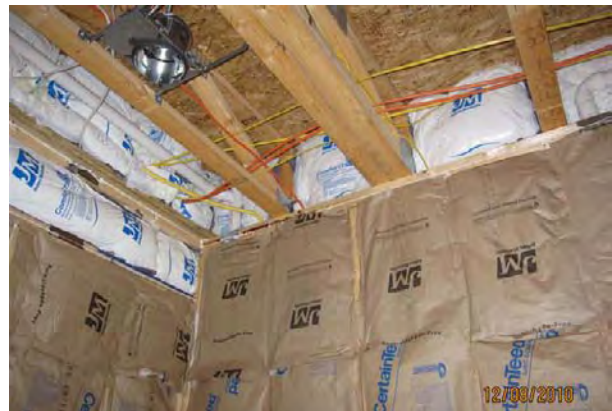
insulation system

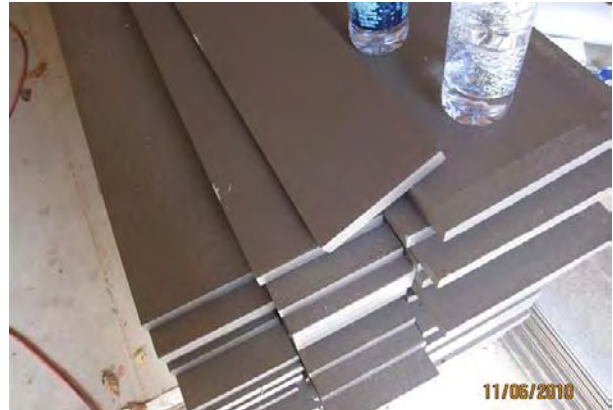
exterior hardiplank material

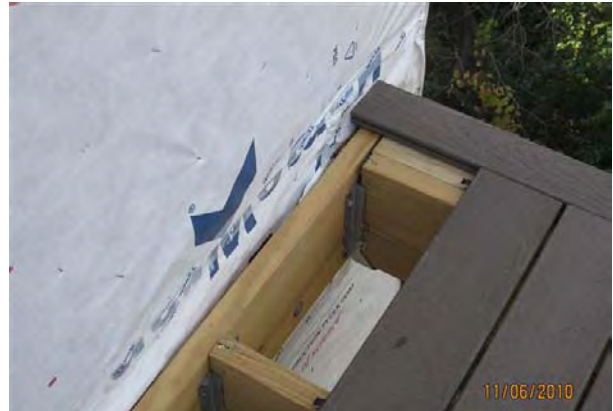
exterior hardiplank decking

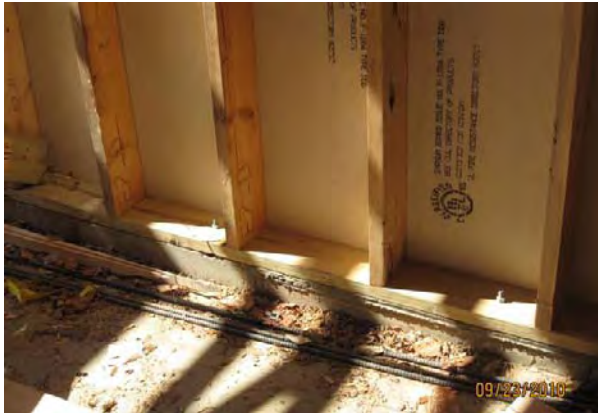
sill plate anchors

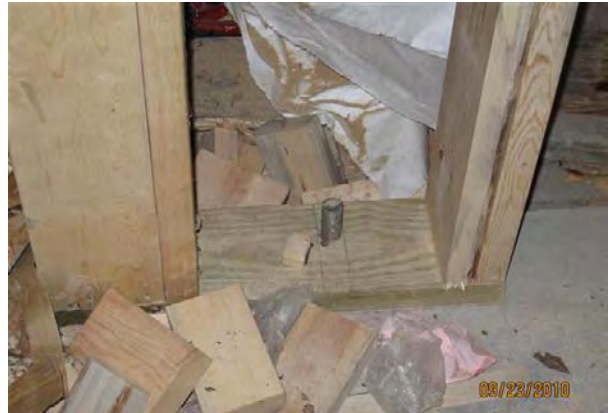
sill plate anchors

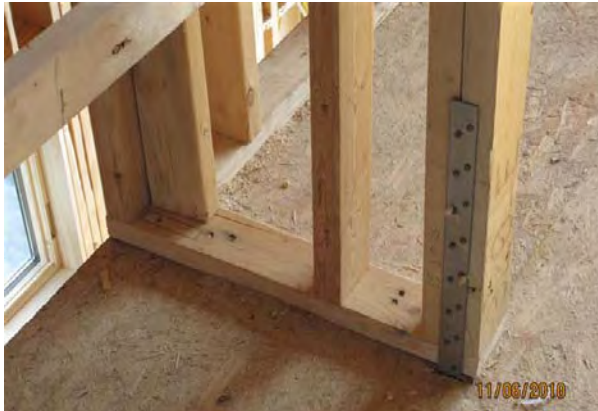
interior hold down strap

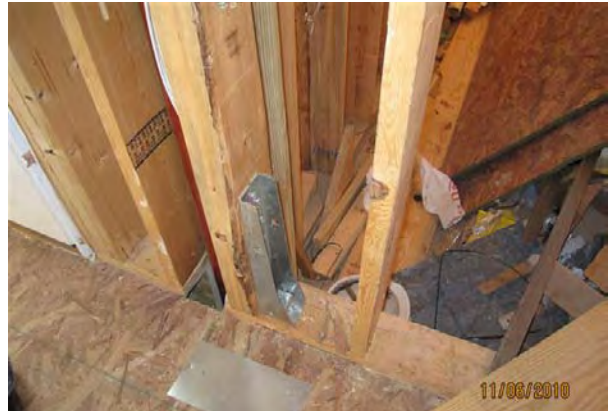
interior hold down brackets

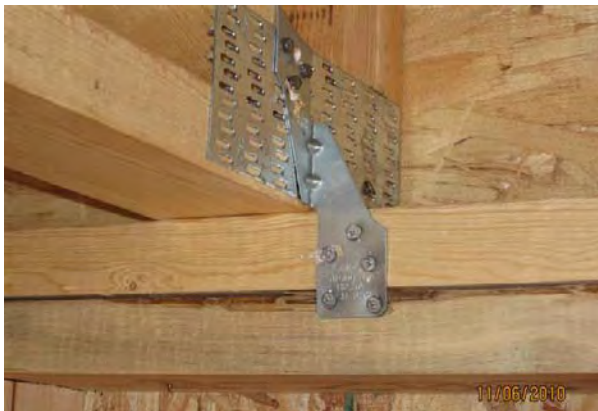
truss hold down straps

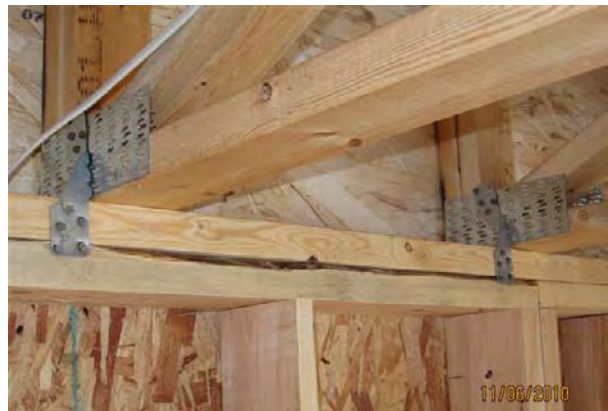
truss hold down straps

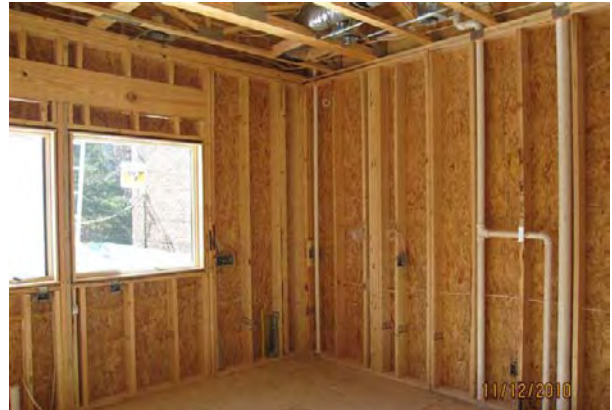
exterior wall corner bracing

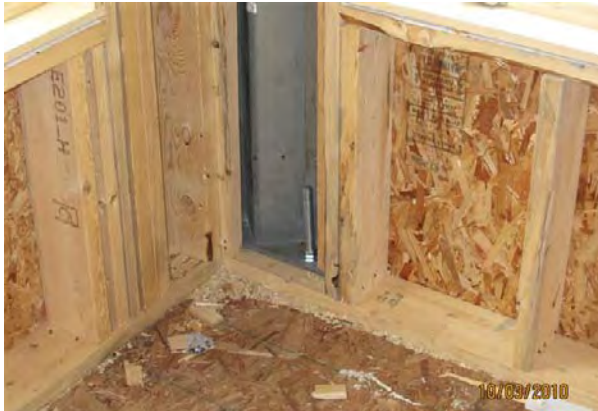
exterior wall cornering bracing, Simpson  
metal corner panels

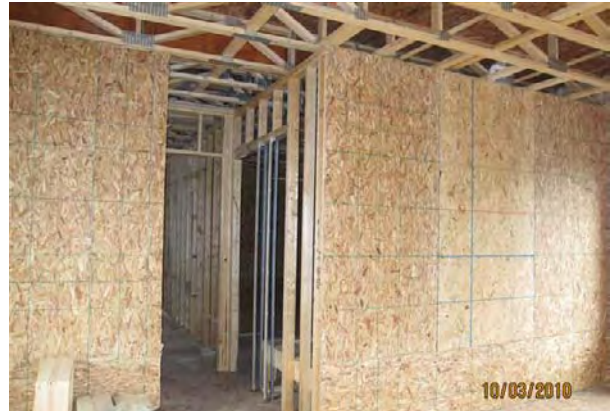
interior shear walls

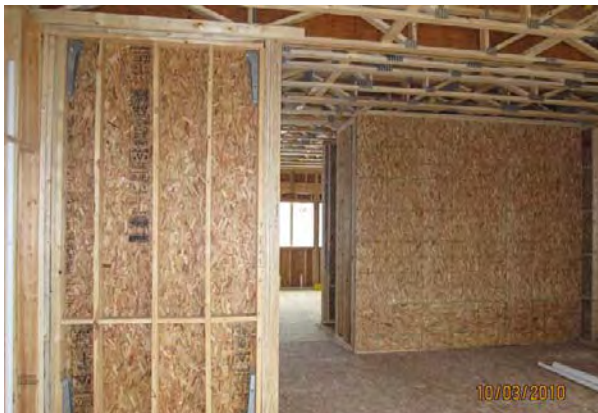
interior shear walls

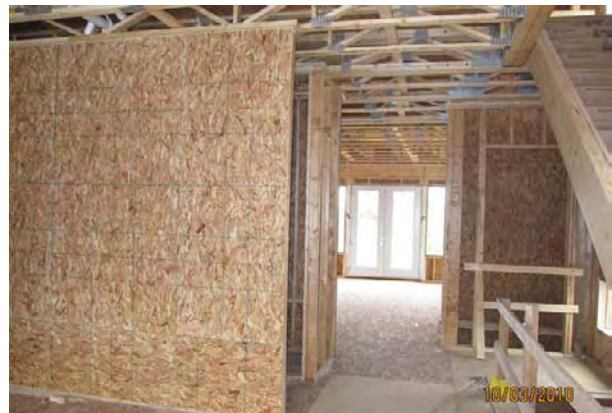
interior shear walls

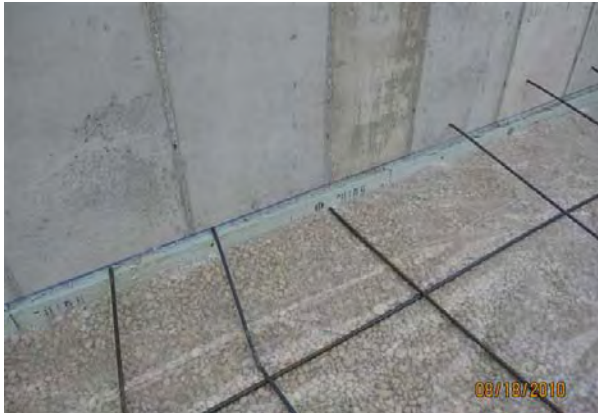
Under slab gravel, underslab vapor barrier
