# Durability Evaluation Inspection Checklist Photos

## Exterior Water / Moisture

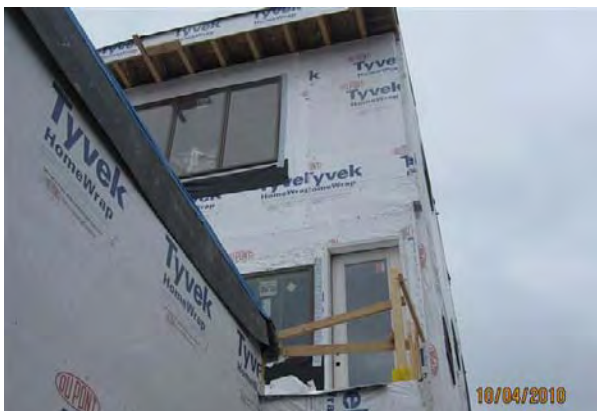
flashing membrane & tape @ openings

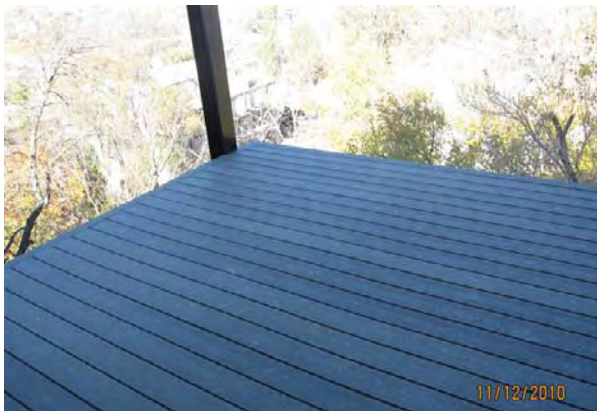
exterior hardiplank decking

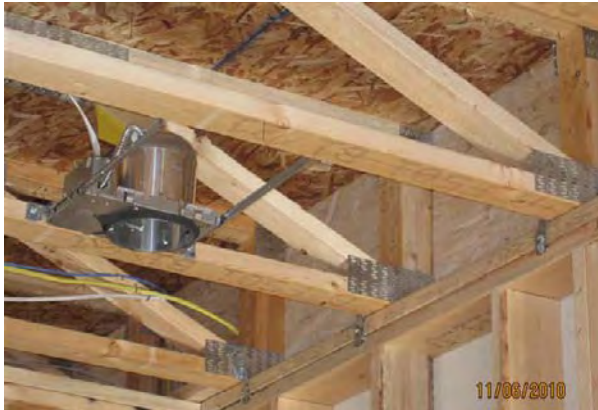
truss hold down straps
