# Durability Evaluation Inspection Checklist Photos

## Exterior Water / Moisture

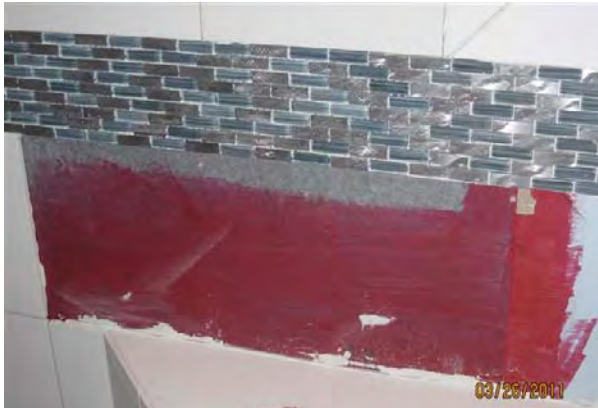
nonpaper faced backer board used in all tub and shower locations

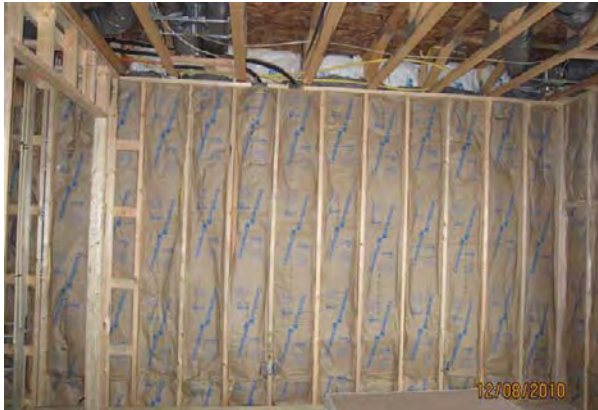
insulation system

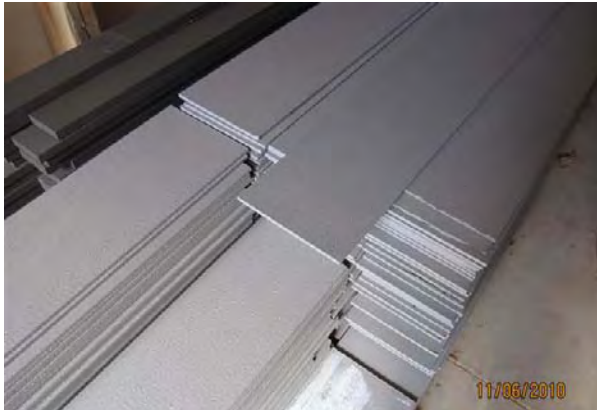
exterior hardiplank material

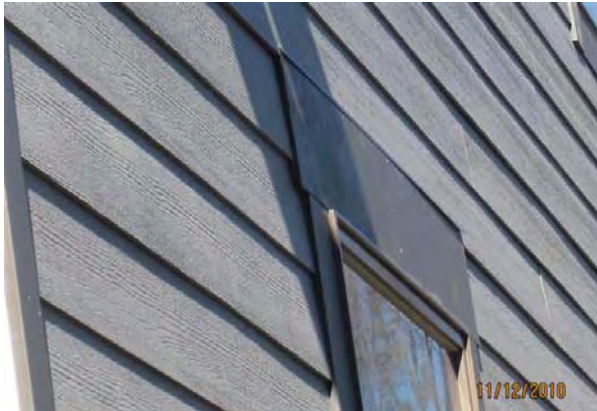
exterior hardiplank siding
